Manhole Inspection Summary

Manhole # S45W__005MH

Location Address: **rear 1536 e clement st**

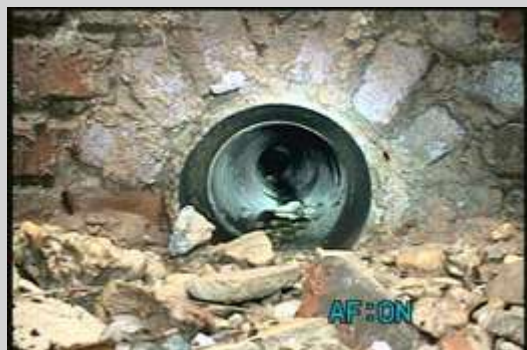
12 O'Clock Outflow

8 in. Circular Gravity Sewer
Pipe Out @ 12 O'Clock

Pipe Material: **Clay** ☐ Pipe Lined

Infiltration: **None** Pipe Seal Cond: **Unknown**
